OFFICER'S HOUSING TYPE 1D

CONDITION SURVEY DATA SHEET

CONDITION SURVEY

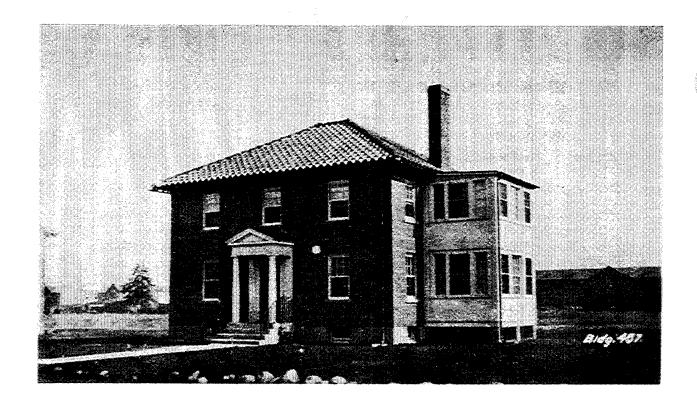
- 1. Shrubs and trees too close to wall. This will accelerate deterioration of walls and windows and clog gutters.
- 2. Columns exhibit water damage at bases. Mitered plinth joints are opening. Stave joints beginning to separate.
- 3. Paint is peeling from lattice skirting, portions in contact with soil are rotting, some slats are missing.
- 4. Chimneys are soiled and mortar is in bad condition. Some need to be rebuilt where corbelling has broken off.

- a. Refer to article on "Wood Columns". Do repair work only when wood has had sufficient time to thoroughly dry.
- b. Small cracks can be caulked or filled with standard wood filler.
- c. Opening joints should be reglued and clamped tight until glue has set.

- a. Lower grade beneath lattice such that lattice is not in contact with soil or "landscape bark".
- b. Replace rotted or missing slats.
- c. Scrape and sand areas of loose paint. Prime and paint.

- a. Refer to article on "Chimneys".
- b. Clean masonry and scrape out all deteriorated mortar.
- c. Replicate original corbelling where existing has broken off or previously been removed.
- d. Match appearance, size, and color of original brick units and match color of mortar.
